ACEE COMPOSITE STRUCTURES TECHNOLOGY

Papers by Douglas Aircraft Company

DAMAGE TOLERANCE AND FAIL-SAFE TESTING OF THE DC-10 COMPOSITE VERTICAL STABILIZER

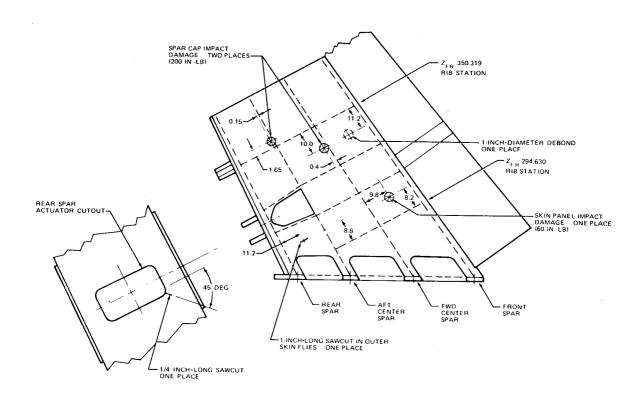
FIGURE 9.

Following the completion of the fail-safe testing and prior to the second fatigue spectrum test, damage was inflicted on the structure as shown in Figure 9. Impact damage was inflicted on the thick spar cap laminate in two locations and in the center of a skin panel bay in one location. A one-inch-diameter debond and a one-inch-long sawcut were made in two other skin panel bays. A 1/4-inch-long sawcut in the corner of the rear spar actuator cutout completed the inflicted damage. Each damage site was inspected ultrasonically to determine the extent of damage not apparent by visual examination. Testing was then resumed and continued through the end of the second life-cycle fatigue spectrum test. None of the damaged areas exhibited any damage growth except for the impact damage to the aft center spar cap at $\rm Z_{FR}$ station 352. NDI checks during the test indicated that the damage in this location increased in size by approximately 40 percent over the initial damage by the end of 21,000 flights (1/2 lifetime). Post-test visual and NDI inspections indicated no further damage growth.

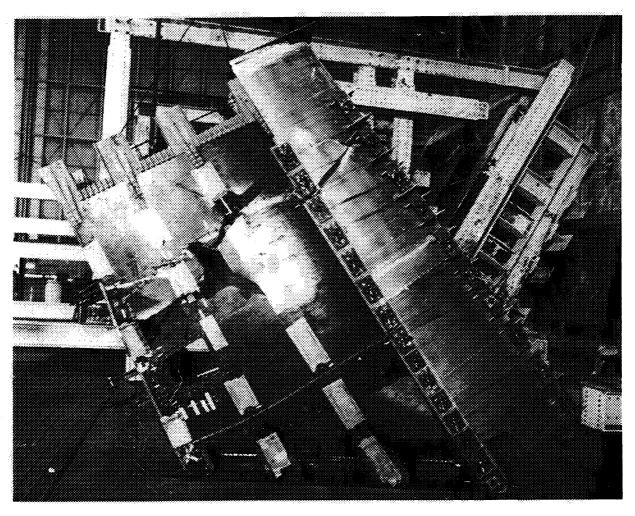
FIGURE 10.

During the residual strength test, loading continued to 144 percent of design limit load (96 percent of design ultimate) when failure occurred suddenly on the compression side. Figure 10 shows the failures in the right skin and leading edge. Although there was no requirement to obtain any specific load level at failure, this failure was considered somewhat premature in that: (1) an undamaged structure would not be expected to fail before reaching 160 percent design limit load, and (2) none of the observed failures occurred through the damaged areas or in the high strain regions in the actuator cutouts.

Posttest investigations revealed that failure originated in the rear spar web at the lower access opening at Z_{FR} station 342. The failure was attributed to high stress concentrations at the edge of the access opening as a result of improper fit in the fasteners attaching the load-carrying access covers to the spar webs. This mode of failure as well as the sequence of failure through the structure were validated by finite-element analysis. The cause of failure was also verified by tests on a representative test panel.

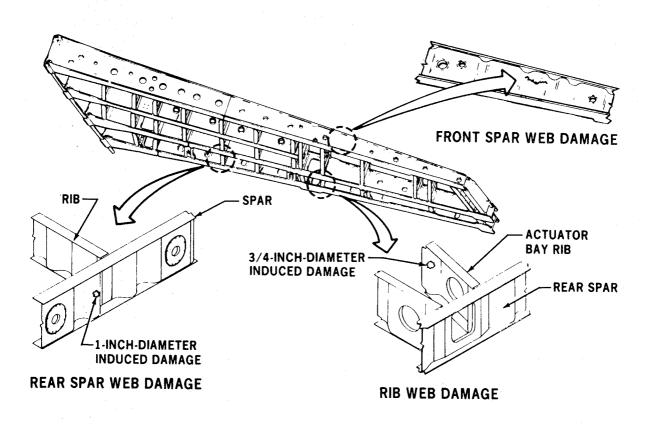
FIGURE 13.

Following the ultimate load test, the test setup was revised in preparation for the second life-cycle fatigue test. Before this test was conducted, impact damage was inflicted in the rear spar web at $Z_{\rm FR}$ station 370 and in the web of the AMC7880-5 rib in the upper actuator bay. These locations are indicated in Figure 13. The intent was to inflict a type of service-related damage that might occur in performing maintenance tasks on rudder actuators or hinge brackets.

Subsequent evaluation of strain data from the ultimate load test revealed that a failure (crack) had occurred in the front spar web approximately 7 feet from the tip. This was confirmed by a visual reexamination of the area after removal of the leading edge fairing at the conclusion of the test program. The data indicated that the failure had occurred at the time the noise was heard at 140 percent of design limit load. This failure is also shown in Figure 13.

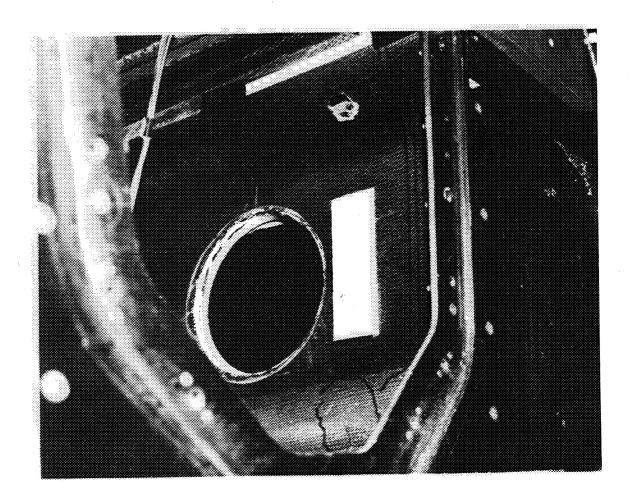
FIGURE 15.

ACTUATOR BAY RIB DAMAGE

The actuator bay rib damage was caused by a 3/4-inch-diameter sharp impactor. The rib web damage is shown in Figure 15. The rib web consists of two plies of carbon/epoxy cloth oriented at \pm 45 degrees.

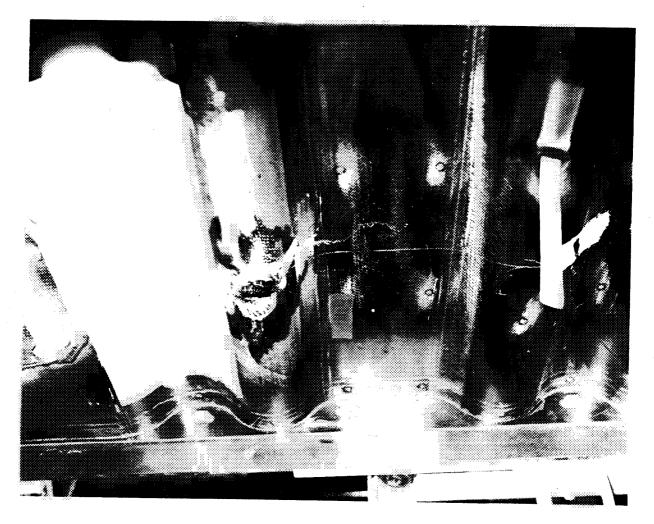
FIGURE 17.

CRACK GROWTH IN REAR SPAR AT 97 PERCENT DESIGN LIMIT LOAD

The structure was loaded in a critical bending condition to 100 percent of limit load. At 97 percent of limit load, a fracture occurred through the damaged area in the rear spar. The loading was continued to 100 percent of limit load, then immediately removed so the crack could be inspected. The crack extended diagonally across the hole for approximately 8 inches. The upper crack tip arrested at the rib intersection and the lower crack tip stopped at a doubler buildup at an access hole. This damage is shown in Figure 17.

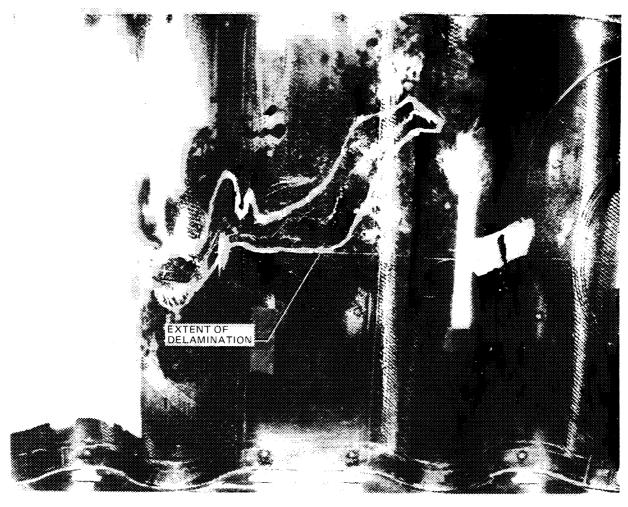
FIGURE 18.

Since the load was immediately removed at 100 percent of limit load after the fracture occurred, the test did not comply with the FAA requirements of a 3-second hold with a full load, and it was necessary to rerun the test. The retest represented a very severe test of the fail-safe capability of the CVS with major damage. This time, full load was held for the required 3 seconds. The crack grew but self-arrested and was stable during the hold period. Posttest visual inspection revealed that the crack grew an additional 5 inches toward the tip past the rib intersection and self-arrested in the middle of the next bay.

Ultrasonic inspection revealed that there were delaminations in the region of the crack. Figure 18 shows the final spar web damage with the delaminated area outlined with white paint. The initial 3/4-inch hole in the actuator bay rib did not change in size during the tests.

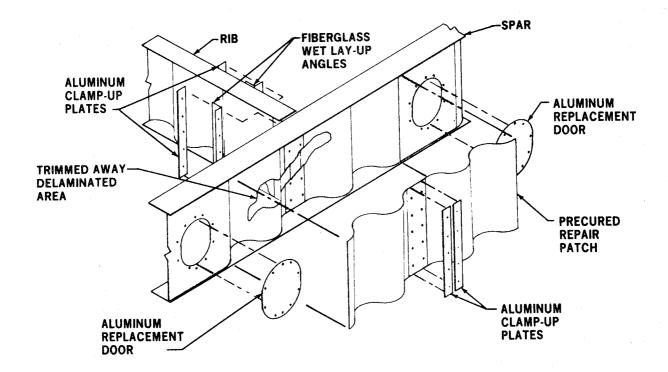
FIGURE 21.

The delaminated area around the crack was trimmed away, leaving an elongated slot which measured 12 inches by 2.5 inches (Figure 20). In addition to the visible damage, it was noticed that the rib-to-spar web attachment angle was separated away from the spar. To ensure that air would not leak through the bond line in this patch, a vacuum bag was used on both sides of the repair. This repair necessitated access to the back, so the two adjacent bonded and bolted access covers were removed, both above and below the damage. For convenience, these doors were subsequently replaced with aluminum doors.

REAR SPAR REPAIR PROCEDURE

Fiberglass angles impregnated with resin were laid over the delaminated ribto-spar attachment angles and allowed to cure. These angles provided a vacuum seal for the inside bag. The vacuum bag setup was tested for leakage and then the structure was prepared for bonding. The patch was trimmed to a 19-inch by 13.5-inch size. Both the patch and the web were grit-blasted and washed with water. The surface preparation was verified by the use of a water-break test. The patch was then bonded, with a scrim cloth backing used to maintain the bond thickness. The outside vacuum bag was sealed and the patch was cured under vacuum pressure and heat. After the cure cycle, aluminum clamp-up plates were bolted through the delaminated rib-to-spar attachment angle to reinforce the angle and prevent further delaminations. Replacement doors were bonded and bolted over the access openings. The repair is shown in schematic form in Figure 21.

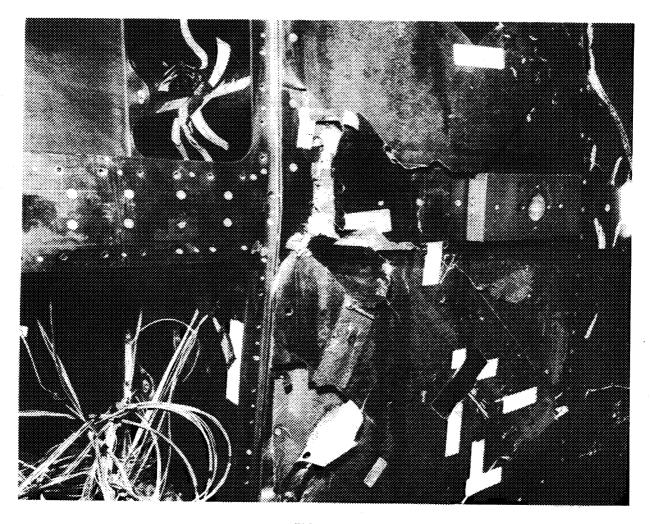
FIGURE 30.

LOCATION OF FAILURE IN AFT CENTER SPAR CAP

The analysis predicted that the failure would occur in the aft center spar cap, directly through a double row of attachments (Figure 30). The strain gage record and high-speed film showed that within one data scan (1/60th of a second) or one film frame (1/48th of a second), the aft center spar cap, the spar web at the same location, and the skin panel directly forward had all failed.

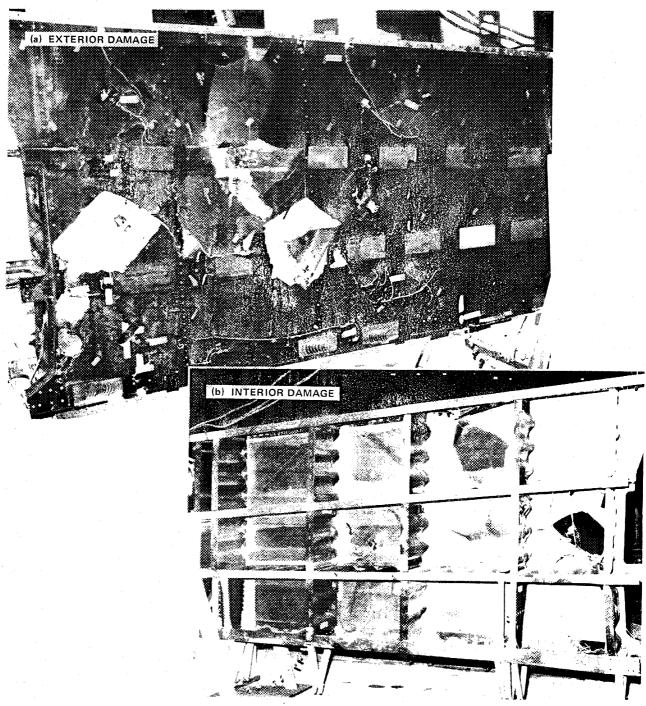
FIGURE 32.

SKIN PANEL TEST DAMAGE

Because of the direction of the shear flow already in the panels, each responds differently. The aft panel experiences essentially a reversal of its shear loading, with almost no effect on its margin of safety. The forward panel, on the other hand, experiences a tripling of its shear flow, which is instantly fatal. Figure 32 shows the central portion of this panel literally blown out of the structure, remaining attached only by the strain gage leads and the peel ply.

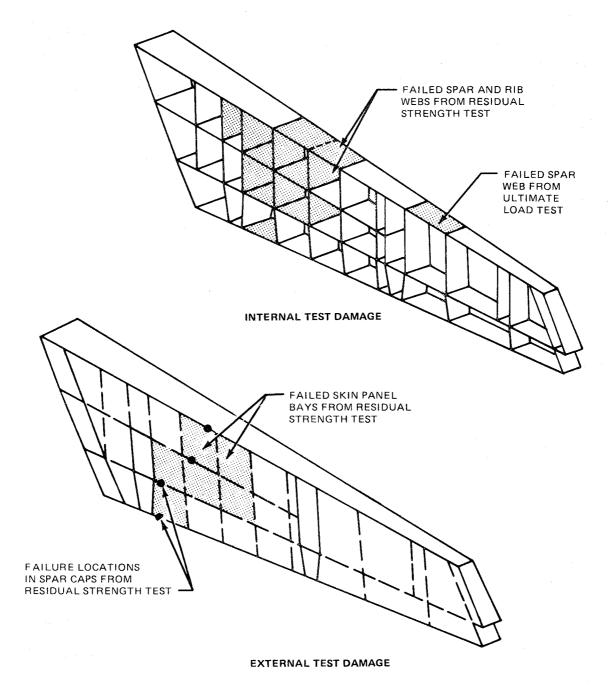
FIGURE 35.

LOCATIONS OF TEST DAMAGE

The final extent of the test damage to the specimen is shown in Figure 35.

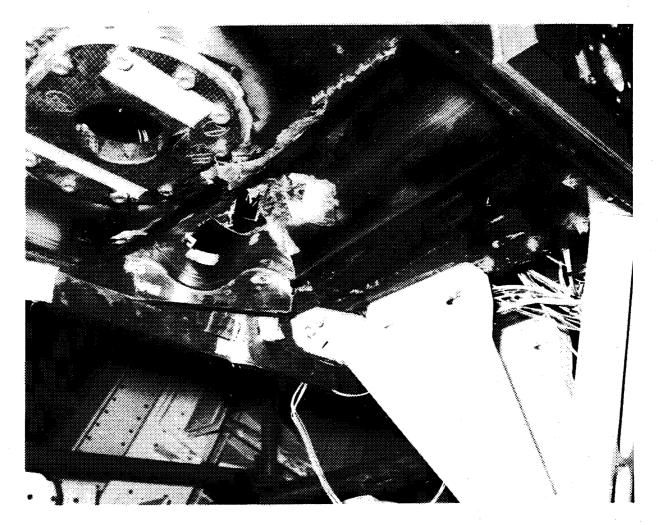
FIGURE 34.

FAILURE IN REAR SPAR CAP AND WEB

Analytically, the next failure in the sequence would be expected in the rear spar cap. The test record shows that no further failures occurred for approximately 0.06 second. This may be attributed to the lag time of the loading system. Again, in one data scan and one film frame, essentially all of the remaining structural damage occurred. Following the failure of the rear spar cap and web (Figure 34), the damage was so extensive that no further attempt was made to establish sequence.
